Structural Challenge Facing the Wireless Communications Industry

A New FRP Solution for Strengthening Concrete Telecommunication Towers

By Mo Ehsani, Ph.D., P.E., S.E. and Ryan J. Rimmel, P.E., S.E.

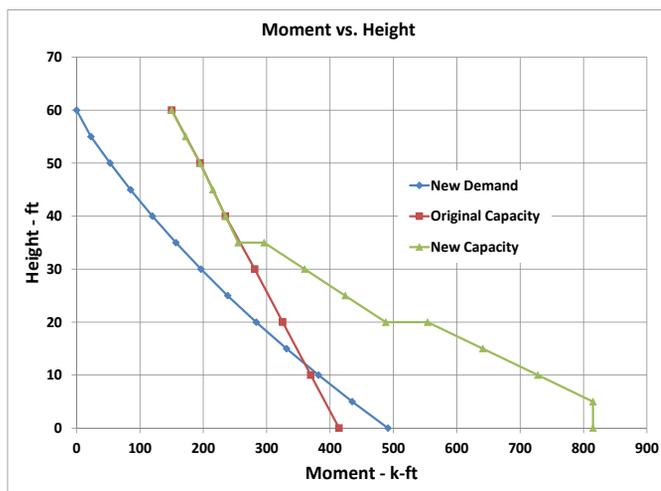
Figure 1. Demand and capacity of the pole at various elevations.

The pole was analyzed for all dead and live load effects, including lateral loads from wind and earthquake. The controlling design moments are shown in *Figure 2*. The original capacity of the pole at the base was about 420 kip-ft. The capacity had to be increased by nearly 50% at the base to resist currently anticipated loads safely. Detailed analysis of the structure demonstrated both compressive, and tensile stresses in the pole exceeded the allowable limits under the new loads. The new design also provides enough reserve capacity to accommodate future additional demands on the tower.

layers were required between 20 and 35 feet. Elevations above 35 feet required no strengthening. The sudden change in capacity of the retrofitted pole at these elevations, shown in Figure 1, is due to the change in the number of layers of carbon fabric. For confinement, and to eliminate any interference with the antennae signals, 2-foot wide bands of a unidirectional glass fabric saturated with epoxy were wrapped in the hoop direction over all of the carbon fabric for elevations 0 to 35 feet (Figure 4).

the existing direct embed pole through load sharing. The forces were proportioned to each foundation element based on the relative member stiffness and soil stiffness. The concrete mat also terminates the FRP. Fifteen No. 8 hooked dowels, extended four feet above grade, transfer the forces from the FRP into the mat foundation. These bars were placed to accommodate the access port for cables entering the core of the tower (Figure 5). The FRP fabric in that region was coated with a layer of sand for improved bond and transfer of stresses. A shell with an outside diameter of 38.35 inches was created at the lower 5 feet, corresponding to a 5-inch thick annular space. As can be seen in Figure 1, this resulted in a very conservative design near the base of the pole.

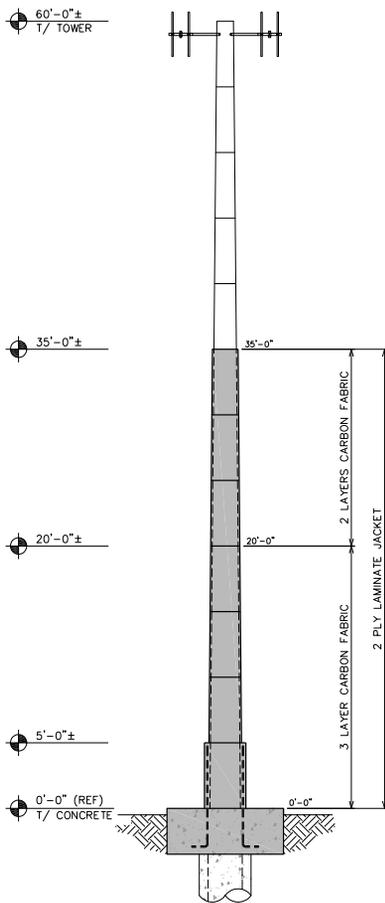
Figure 2. Elevation of the pole for the retrofit scheme using FRP.

Among the options considered, the use of FRP offered the most viable solution (Figure 2). The repair technique offered the flexibility to easily change the strength of the pole along the height. Tension reinforcement for the pole was provided by bonding unidirectional carbon fabrics to the exterior surface of the pole. The carbon fabric used for this project was supplied in 24-inch wide rolls and had a tensile strength of over 6 kips per inch of width of the fabric. The fabric can be cut into narrower bands for ease of installation without any adverse effect on its strength.

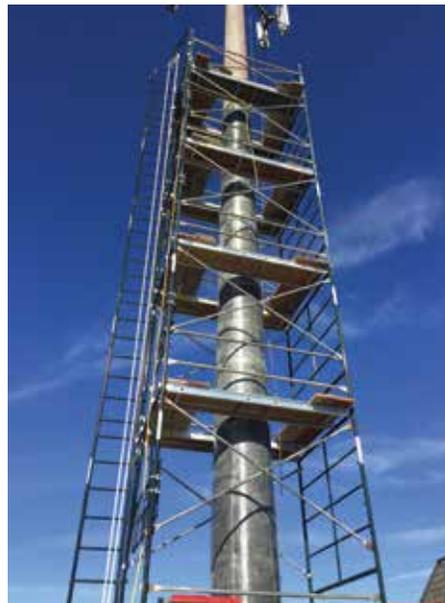
Figure 3. Carbon and glass FRP fabric applied to the lower 35 feet of the pole.

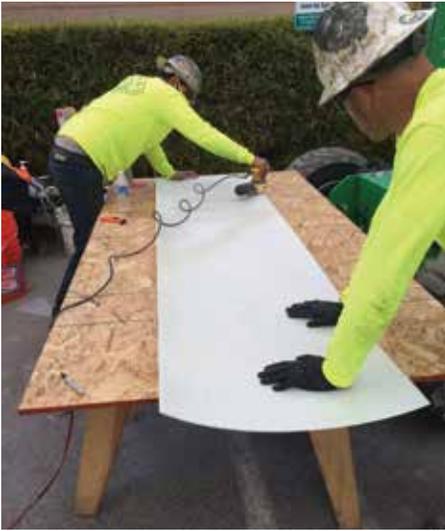
Figure 4. PileMedic laminates being cut to size on the job site before it is wrapped around the pole.

PileMedic® laminates are made by saturating rolls of fabric with resin and running them through a special press that applies heat and pressure, resulting in 4-foot wide rolls with a thickness as little as 0.01 inch. The relatively large width and small thickness of the laminates make their manufacturing unique and challenging. The thin laminates can be easily cut (Figure 4) and wrapped around a column of any shape or size in the field to create a stay-in-place form that can be filled with grout or resin.

The properties of these laminates are listed in the Table. Depending on their composition, the laminates offer exceptional tensile strength in the longitudinal direction, or in the longitudinal and transverse directions. For this project, the biaxial glass laminate with a thickness of 0.026 inches was used. For the region between 5 and 35 feet, the 4-foot wide laminates were coated with an epoxy paste and wrapped around the pole to create a two-ply shell. Temporary 1½-inch thick spacers, such as a PVC pipe, can be attached to the pole surface to facilitate the wrapping of the laminates with the necessary standoff distance. By overlapping the 4-foot wide laminates by 4 inches, a long shell was created in the field that covered the pole at the necessary elevation.

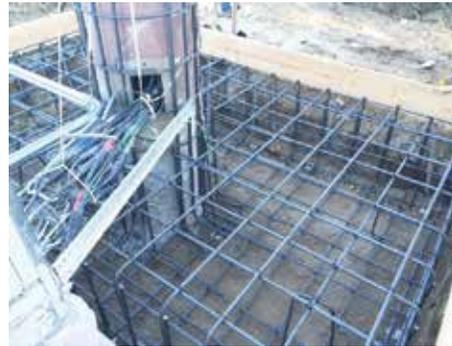
Figure 5. Foundation and the steel dowels at the base of the pole.

At the base of the pole, a new 9-foot x15-foot x1.5-foot concrete mat foundation was installed. The rectangular shape was required to fit within the tight footprint of the tower compound. The new foundation reinforces

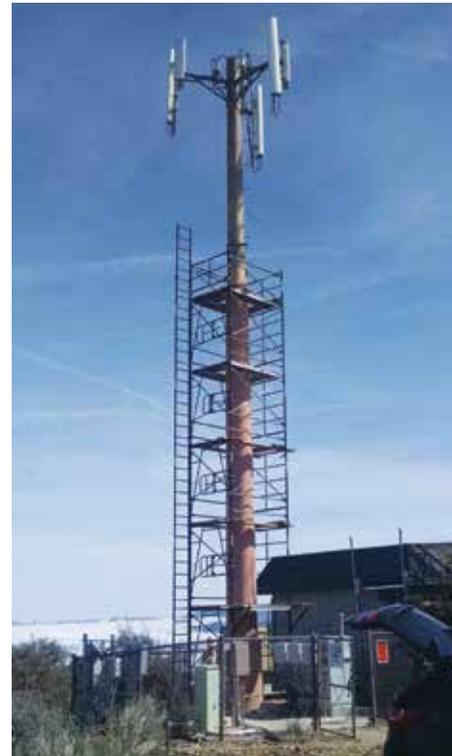
Figure 6. Painted pole at the conclusion of the project.

The structure is a 75-foot long hollow precast concrete pole located in Tehachapi, California (*Figure 6*). The bottom 15 feet of the pole is directly embedded in the soil, leaving the remaining 60 feet above ground. The outside diameter of the pole ranges from 31.59 inches at 15 feet elevation to 15.39 inches at 60 feet elevation. The thickness of the tube tapers from 3.4 to 2.5 inches, respectively. Reinforcing steel is comprised of twelve ½-inch diameter 270k seven-wire strands uniformly placed around the circumference. The design compressive strength of concrete was 9500 psi.

The strengthening solution presented herein takes approximately 4 days to install. The lightweight laminates eliminate the need for any heavy equipment, and all work can be accomplished using scaffolding (Figure 6). The finished laminates are coated with a UV-resistant coating. Many cables and appurtenances that were near or attached to the pole were moved slightly to accommodate the FRP and concrete placement; these were eventually relocated back to their original positions (Figures 4 and 5). This design approach allows the pole to remain fully operational during the repair, with little change in the appearance and size of the pole.
